Navajo Abandoned Uranium Mine

Site Screen Report

Jackpot No. 5 AUM Site

January 2011

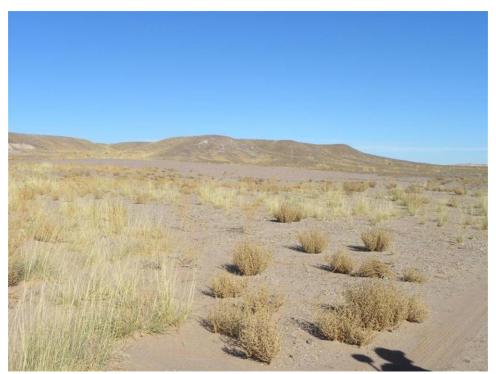
Photo 1. Jackpot No. 5 mine site

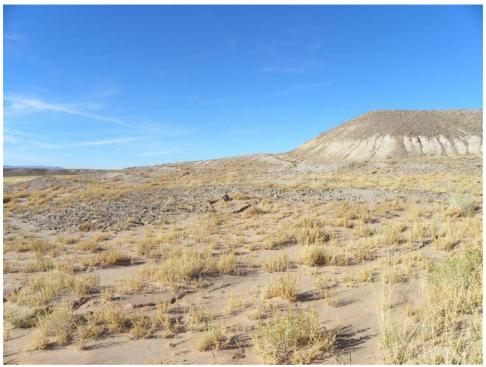
Large reclamation cap beneath what appeared to be old workings, grey granular material, 450' x 200'

Photo 2. Jackpot No. 5 mine site, reclamation cap area

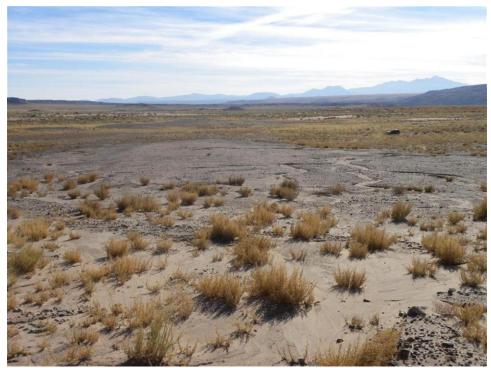
Photo 3. Jackpot No. 5 mine site, discolored soil immediately N of the site
